# Report Index

# INFORMATION NOTES

The dwelling was a new construction.

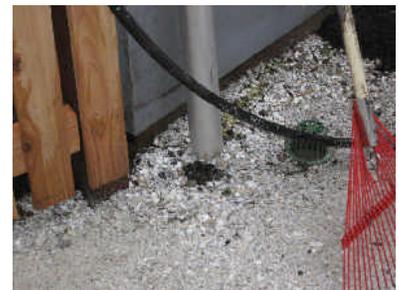
- Grading**                            Minor adjustments of the grading at the foundation would be beneficial. This condition was observed on the Left Side.

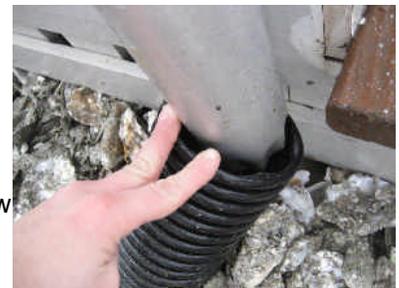
The downspout(s) were not properly extended. This condition will allow roof water runoff to pool near the foundation, which could lead to moisture related conditions.

This condition was observed on the Left Side.

*SUGGESTION:* The discharge from all the downspouts should be routed away from the dwelling. This will ensure that the water will flow away from the dwelling and back toward the foundation.

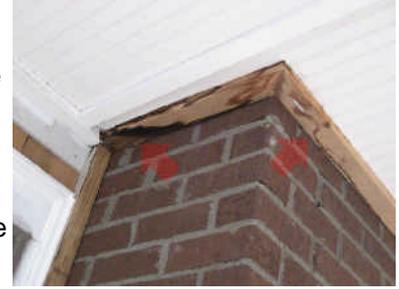
Some of the Exterior Cedar Trim was deteriorated and showing signs of moisture. No direct leak could be leak located at the time of inspection yet yet testing with a moisture meter detected levels exceeding 30% at cedar trim that wraps the chimney.

This condition was observed on the Right Side.

*SUGGESTION:* We recommend repair or replacement to restore its proper function. One possibility is that the trim actually wicking moisture from the chimney itself. We were not able to verify this at the time of inspection and your contractor should be consulted.

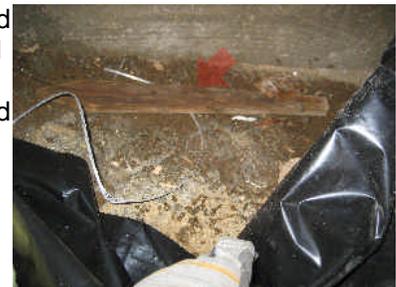
Form-wood, cardboard on the ground or around the piers and/or scrap wood was left on the soil or at the base of the foundation in the Crawl Space. Cellulose debris can easily harbor wood destroying organisms.

*SUGGESTION:* Removal of all wood or other material containing cellulose in direct contact with the soil is recommended, to reduce a condition conducive to infestation by wood destroying organisms.

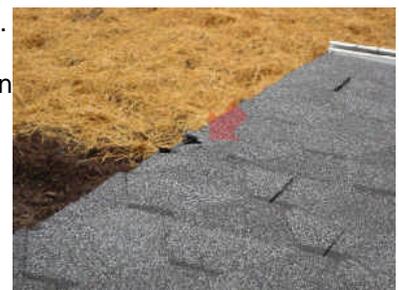
**Condition** The roof surface has torn a shingle over the.....

*SUGGESTION:* It is recommended that this torn shingle be replaced as necessary to prevent further possible damage to the adjacent areas or future leakage.
